# ADVANCED METALLIC AIR VEHICLE STRUCTURE PROGRAM

SIXTH INTERIM REPORT

GENERAL DYNAMICS  
FORT WORTH DIVISION

TECHNICAL REPORT AFFDL-TR-76-74

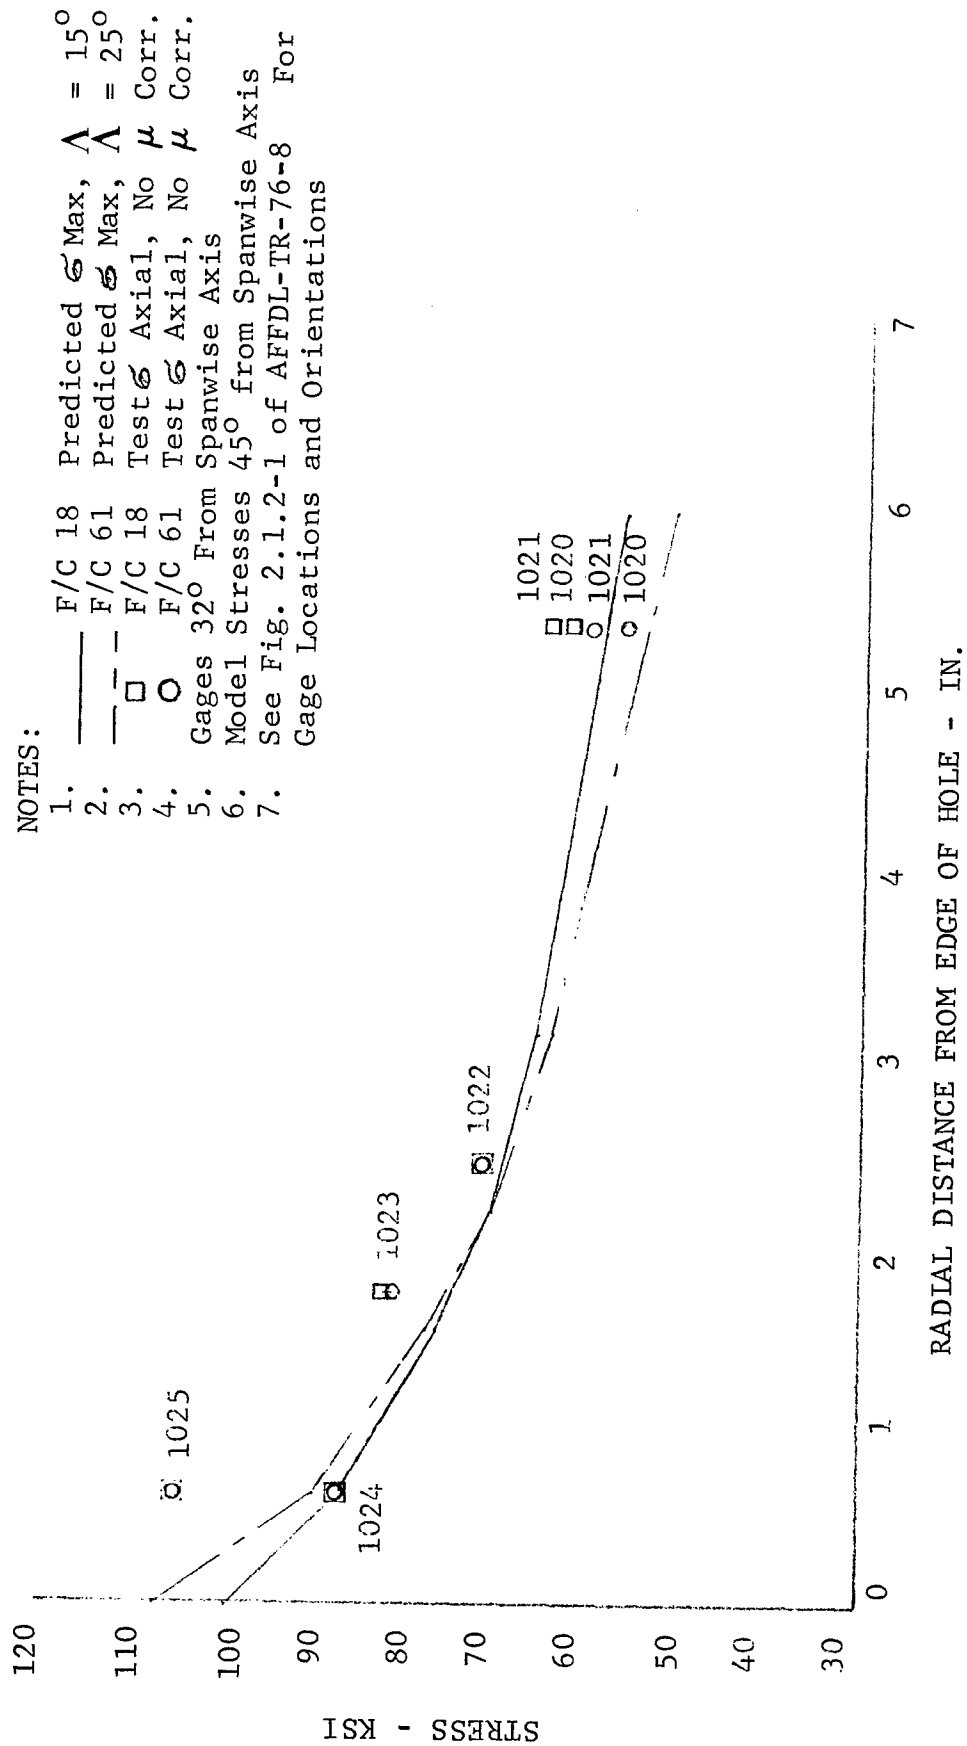
Figure 2.1.2-2

WCTS LOWER PIVOT LUG  
TYPICAL MEASURED AND PREDICTED STRESSES

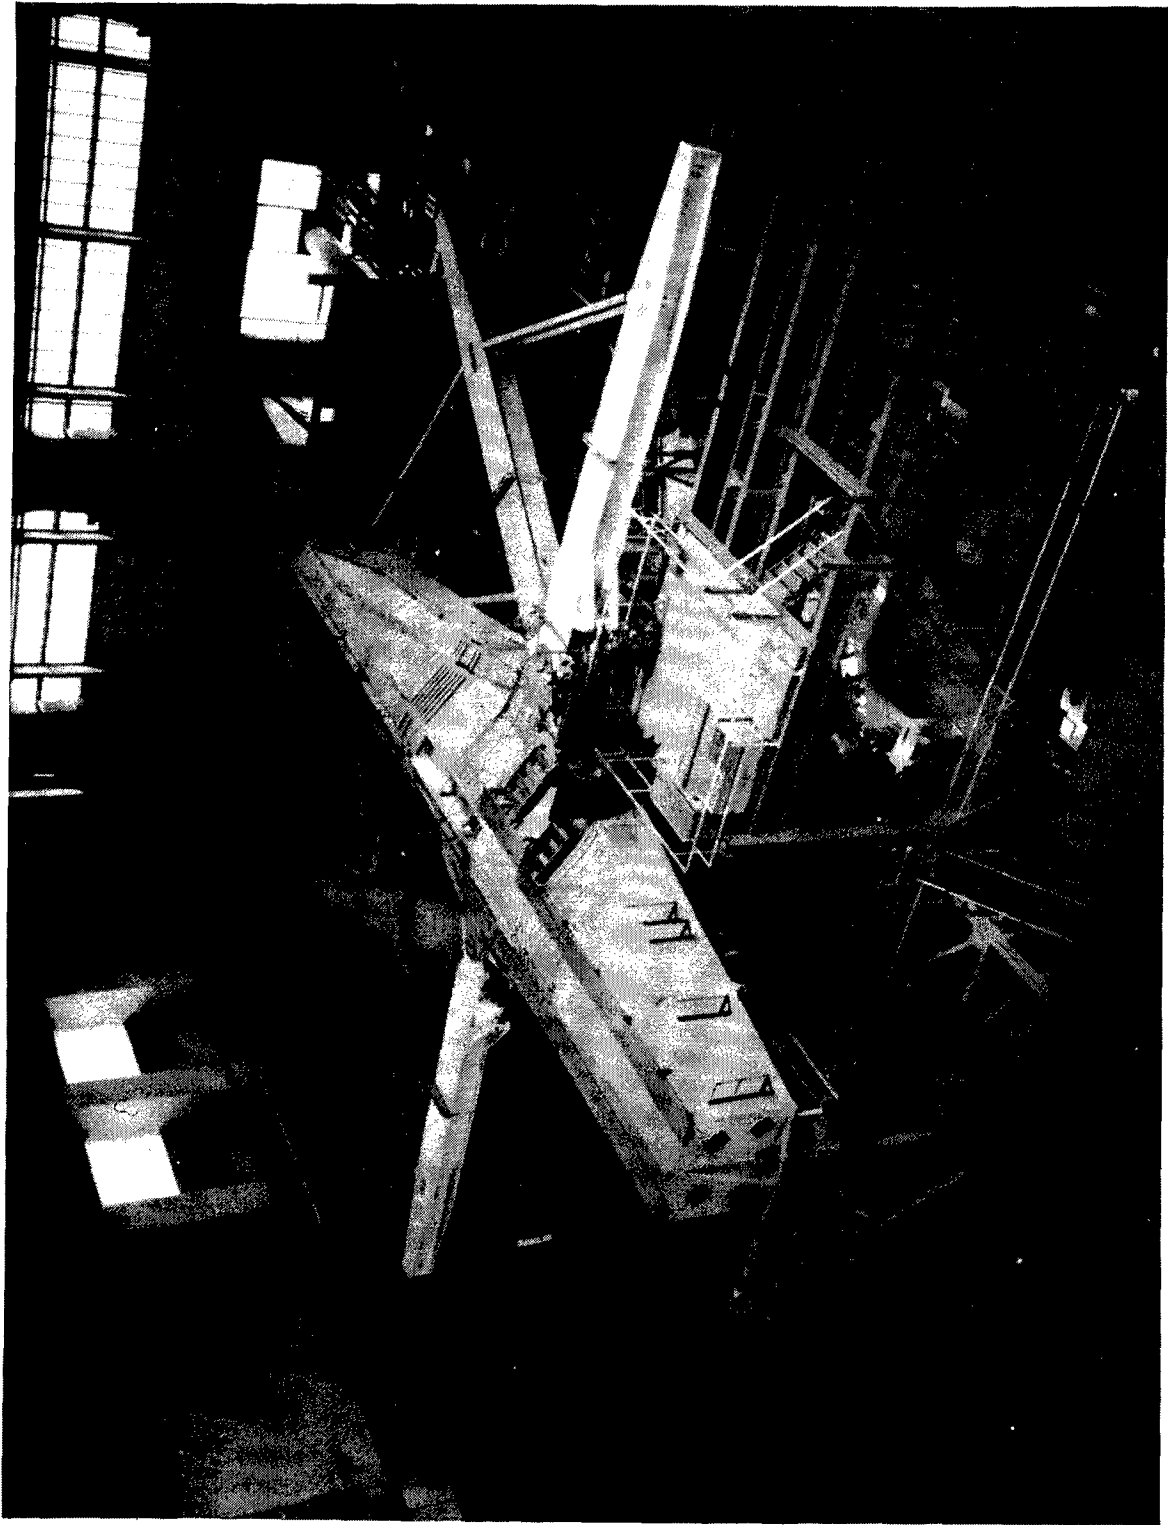
FIGURE 2.2.1-1  
FULL SCALE TEST SET-UP

Fatigue testing was initiated on 21 October 1975 utilizing the Full Scale Test Set-Up shown in Figure 2.2.1-1. Except for test system problems, which were expected for a complex system, testing was essentially uneventful for the first one-eighth service life (160 flights).

When the first 160 flights of the testing were completed, the scheduled Category II visual inspection was accomplished. Numerous fasteners were found to be loose in the Y<sub>F</sub> 992 bulkhead access panels and in the simulated fuselage structure, especially from Y<sub>F</sub> 992 to Y<sub>F</sub> 1050. These fasteners were all retorqued.
